Location: Damariscotta River, Towns of Damariscotta and Newcastle, Lincoln County, Maine

<u>Purpose</u>: Standard lease for the bottom culture of Eastern/American oysters (*Crassostrea virginica*), European oysters (*Ostrea edulis*), hard clams (*Mercenaria mercenaria*), Atlantic surf clams (*Spisula solidissima*), and razor clams (*Ensis directus*)

May 8, 2018

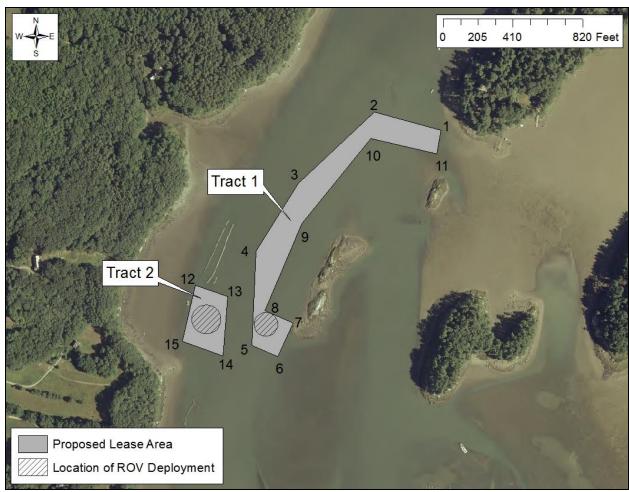
**Figure 2:** Proposed lease area using geo-referenced aerial photographs provided by The Maine Office of GIS (Low\_Tide\_2004).

On April 5, 2018 a Remotely Operated Vehicle (ROV) was used to document the epibenthic ecology of the surrounding area. Figure 2 displays the approximate location of where the ROV was deployed on each tract of the proposed site. The section of Tract 1 observed by MDMR staff was composed primarily of firm mud and sand substrate (Image 8). Gravel, firm mud, and sand was observed on Tract 2 (Image 9). The relative abundance of epibenthic macro flora and fauna observed throughout the video transects is described below.

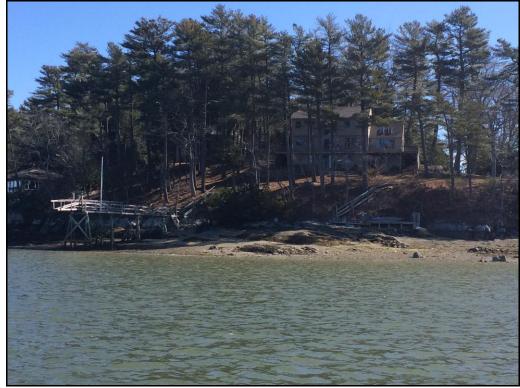
Houses, stairways providing shoreline access, and docks are located to the north of proposed Tract 1 on the Damariscotta River's eastern shore. The closest dock is located ~210 feet to the north of the proposed lease (Image 7). Due to the date of MDMR's site visit, a ramp and float were not yet installed and therefore any vessels associated with this property were not observed. A stairway leading down the steep upland to the water is located next to the dock, approximately 205 feet to the north of the proposed lease (Image 7). A kayak was observed nearby this stairway indicating that riparian owners launch hand-carry vessels from this shoreline.

**Image 7:** Houses, docks, and stairways to the north of, and nearest to, Tract 1 (April 5, 2018).

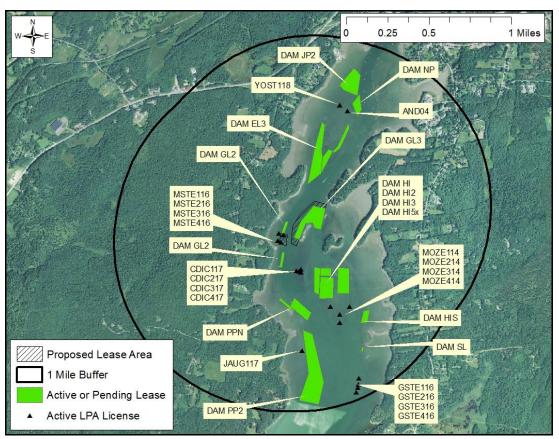
There are thirteen active or pending aquaculture leases and nineteen active Limited Purpose Aquaculture (LPA) licenses within one mile of the proposed lease site (Figure 3). Table 2 lists leases and licenses within 1000 feet of the proposal. At the time of MDMR's site visit, work was being conducted on some of the nearby leases and LPA licenses.

**Figure 3:** Active and pending aquaculture leases and licenses nearby proposed lease site using aerial photographs provided by The Maine Office of GIS (NAIP\_2013).

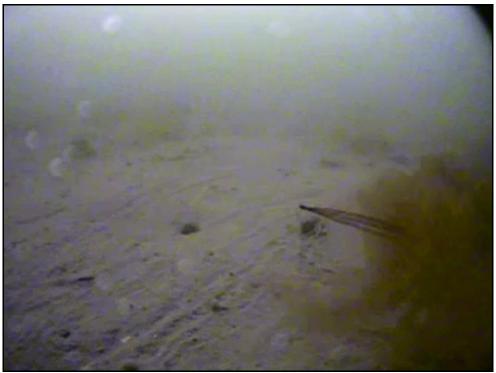
sediment samples were taken or grain size analysis performed. The bottom of the southern portion of Tract 1 is composed of fine unconsolidated substrate, primarily firm mud and sand. Shell hash was also observed. Slightly gravelly sandy mud with co-occurring woody debris was observed on the bottom of Tract 2.

**Image 8:** Bottom of proposed Tract One (April 5, 2018).

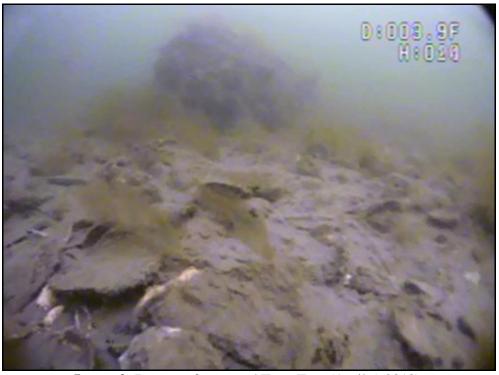
**Image 9:** Bottom of proposed Tract Two (April 5, 2018).

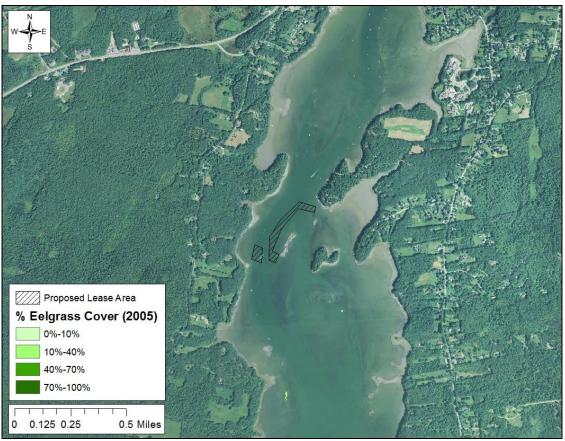
According to data collected by the Maine Department of Marine Resources, the closest historical record of eelgrass to the proposed lease site was observed in 2005 and located over 3,000 feet to the south (Figure 4). No eelgrass was observed during the Department's underwater site assessment on April 5, 2018.

**Figure 4:** Historical records of eelgrass (*Z. marina*) in the vicinity of the proposed lease area using aerial photographs provided by The Maine Office of GIS (NAIP\_2013).<sup>4</sup>

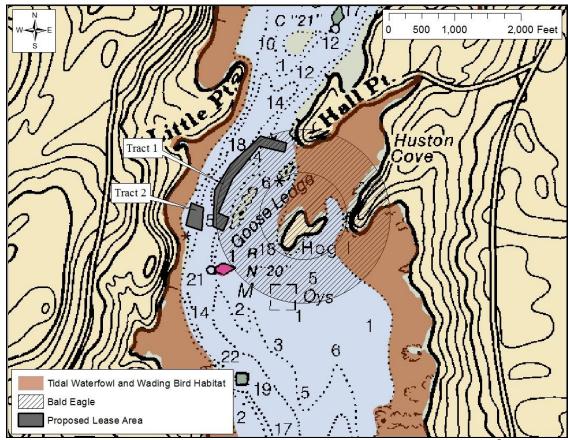
According to GIS (Geographic Information System) data maintained by MDIF&W and available through the Maine Office of GIS, the majority of proposed Tract 1 lies within the mapped habitat of a bald eagle (*H. leucocephalus*) nest located to the east of the site (Figure 5). Additionally, the intertidal areas to the east and west of the proposed lease tracts are categorized as Tidal Wading Bird and Waterfowl Habitat (Figure 5). Tidal Wading Bird and Waterfowl Habitat is defined under Maine's Natural Resources Protection Act (NRPA) as Significant Wildlife Habitat.

**Figure 5:** Endangered, Threatened, and Species of Special Concern Habitat<sup>5</sup> and Tidal Wading Bird and Waterfowl Habitat<sup>6</sup> in the vicinity of the proposed lease site
